ENVIRONMENTAL HEALTH & ENGINEERING

WHAT YOU NEED TO KNOW ABOUT MANAGING
PCBs IN CONSTRUCTION MATERIALS - AN
EMERGING ENVIRONMENTAL ISSUE

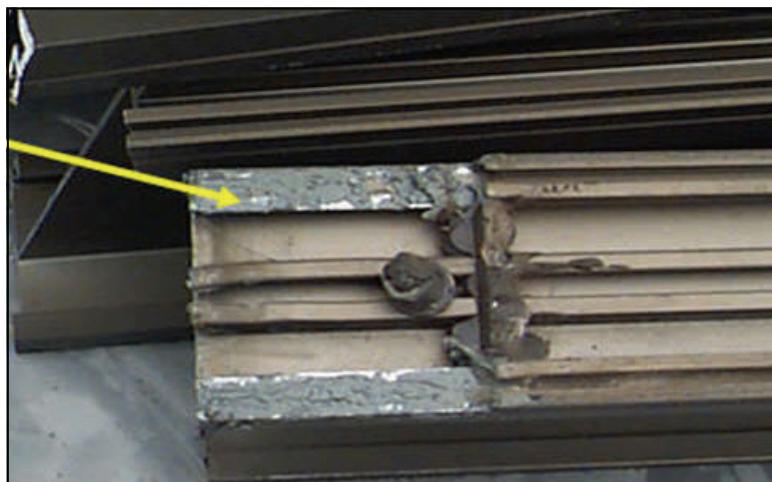
Figure 1: Caulking in contact with window frames. A recent study demonstrated that 1/3 of buildings contained caulking with levels of PCBs⁴ well above allowable limits set by the EPA.

A recent study demonstrated that 1/3 of buildings contained caulking with levels of PCBs⁴ well above allowable limits set by the U.S. Environmental Protection Agency (EPA). Based on data provided by the National Institute for Occupational Safety and Health (NIOSH), the “peak” production years for PCB-containing caulking were from the 1960’s through the early 1970’s⁵. Buildings constructed or renovated during this period are at high risk for having PCB-containing caulking. U.S. Census Bureau data for this time frame indicate that approximately \$335.8 billion of private and public educational buildings were constructed in this “high risk” timeframe⁶.

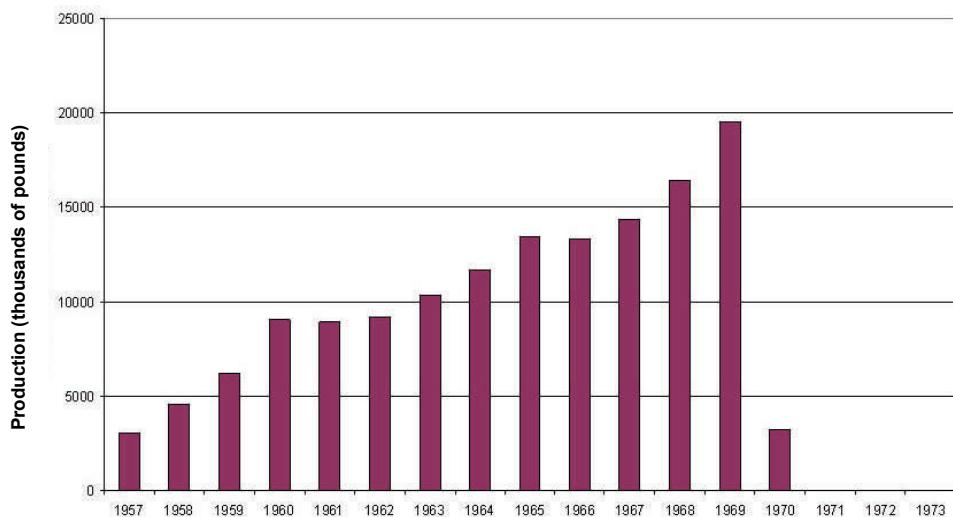
Figure 2: Production of PCBs used as plasticizers (data from Monsanto Industrial Chemicals Company, 1975)⁵.

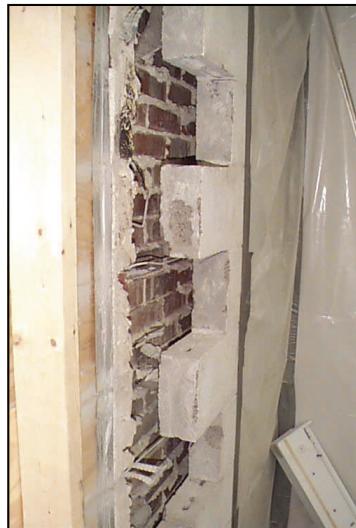
Figure 3: PCB remediation projects often include the removal of materials in contact with the PCB caulk due to unacceptable levels of residual PCB contamination.

building components that come in contact with caulking will often become contaminated to various degrees based on the porosity of the material. Analyzing the extent of the contamination can often make a significant difference in remediation effort and cost. Wholesale removal of sections of a façade may be avoided by accurately determining the extent of PCB penetration into surrounding materials, which can significantly reduce the cost and time for remediation. Further, the regulations allow for both a prescriptive clean-up procedure as well as a risk-based clean-up procedure. Both approaches have their merits and drawbacks, and it is important for any building owner to carefully consider each clean-up option; and select the approach that best satisfies his/her unique needs and asset management strategy.
