## Soil Contamination from PCB-containing Buildings

**Robert F. Herrick, Daniel J. Lefkowitz, George A. Weymouth**  
**doi:10.1289/ehp.9646 (available at <http://dx.doi.org/>)**  
**Online 6 November 2006**

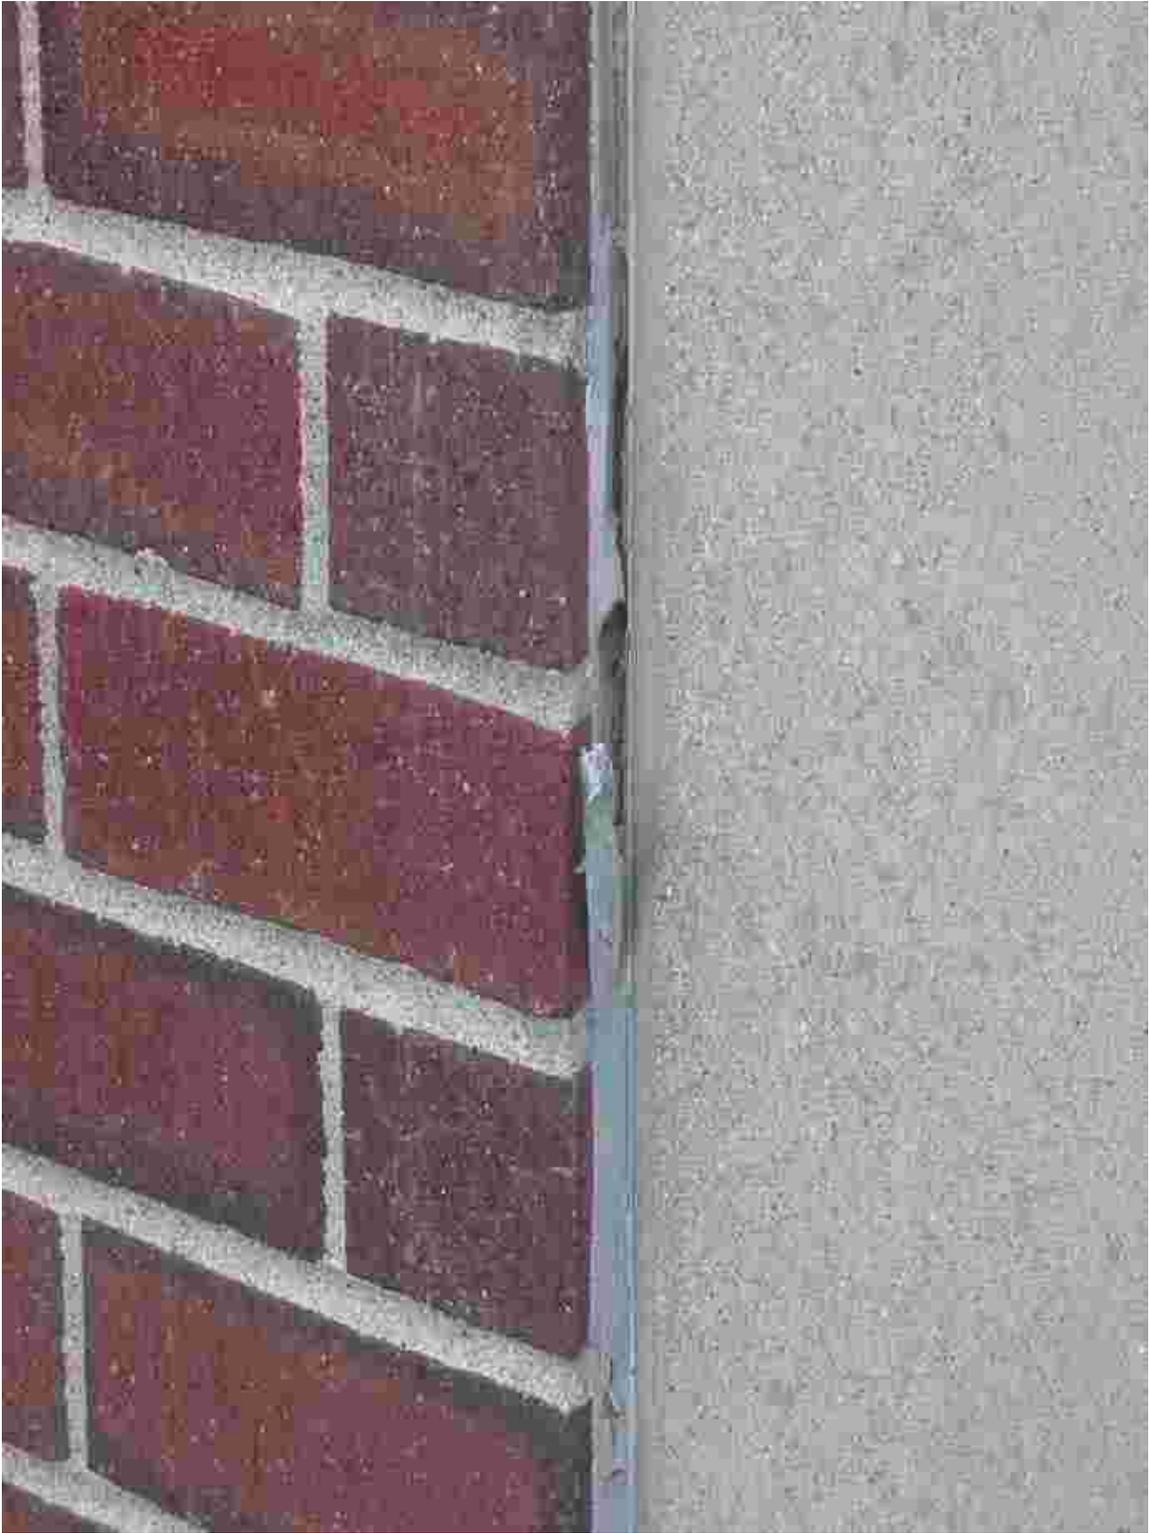
Figure 1 – Deteriorated PCB caulking in a building expansion joint

material is at least 30 years old, it may be degraded to the point that the PCBs, which were plasticizers in the original polysulfide polymer formulations, can be mobilized into solution. In some cases, the caulking has clearly lost its elasticity (Figure 1) and the extent of degradation in any caulking material sample may be a better predictor of the amount of PCB that can be mobilized than the bulk PCB content of the caulk.
