PCB IN BUILDING SEALANT IS INFLUENCING PCB LEVELS IN BLOOD OF RESIDENTS

Niklas Johansson^{1,2}, Annika Hanberg², Håkan Wingfors³ and Mats Tysklind³

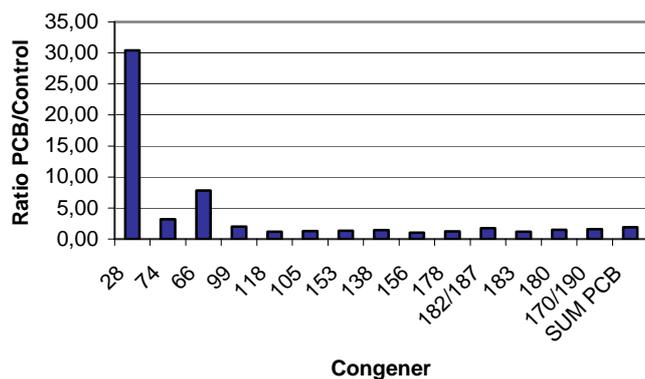
Elevated levels of different PCB congeners found in blood from individuals living in houses where PCB containing sealant was used

Figure 1: Relative elevation of PCB levels in blood in individuals from “PCB flats” related to levels from control flats.

Using the above-mentioned technique, it was possible to detect some 30 different PCB congeners. Among these some 15 could be quantified in all samples, whereas congeners as 101, 110, 141, 157, 174, 177, 172/192, 189, 201, 196/203, 206 and 209 could be quantified in a limited number of samples. Among the congeners that could be identified in all samples elevated levels were found in samples from individuals living in the "PCB flats" (Figure 1, Table 1). Most congeners were only slightly elevated (1.2 to 3.2 times) but the two low-chlorinated congeners 28 and 66 were detected at several times higher levels (30 and 9 times).

The elevation of the levels of the low-chlorinated PCBs is illustrated in Figure 1. It could be interesting to note that, despite a large inter-individual variation, the median concentration was found to be elevated for all of the major PCB congeners in blood from individuals that had lived in "PCB flats". The statistical evaluation of the same data is presented in Table 1 and it should be noted that reliable difference between the two groups is not only recorded for PCB 28, 74, 66 and 99 but also for total PCB based on some 30 different congeners.
